Manhole Inspection Summary

Manhole # S2100_017MH

Location Address: **2275 REISTERSTOWN-WOODBROOK** Cross Street: **RUSKIN AVE**

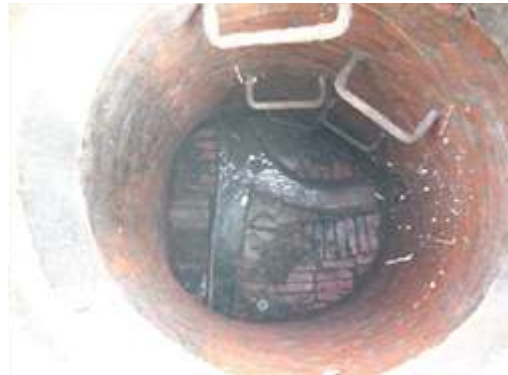
Top View

DEBRIS ON BENCH

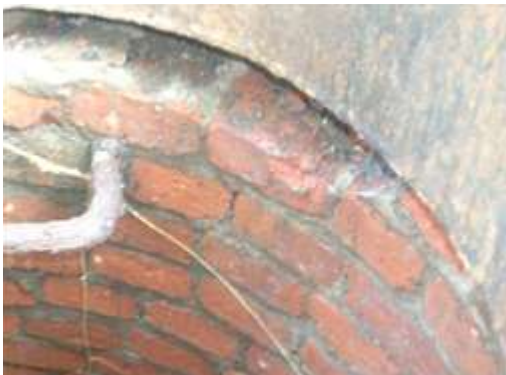
Defect 2

Corbel Material: **Brick** ☐ Parged Type: **Concentric/Eccentric**
Condition: ☐ Sound ☐ Cracked ☒ **Root Intrusion** ☐ Loose Brick ☒ **Deteriorated**
Infiltration: ☐ None ☒ **Joint** ☐ Cracks ☐ Mortar ☐ Roots ☐ Wall

DETERIORATION OF CORBEL

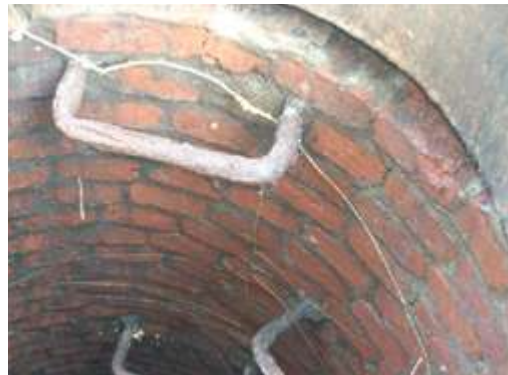
Defect 4

Steps Count: **6** Missing: **0** ☒ **Corroded**

CORRODED STEP

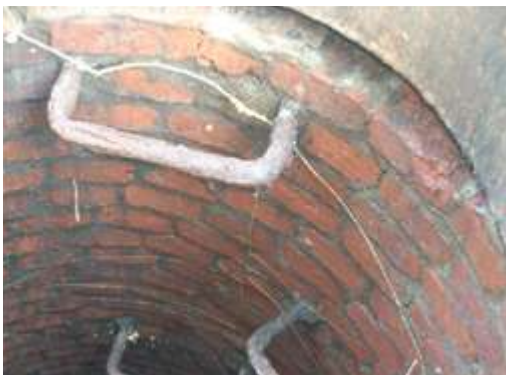
Defect 1

ROOT INTRUSION

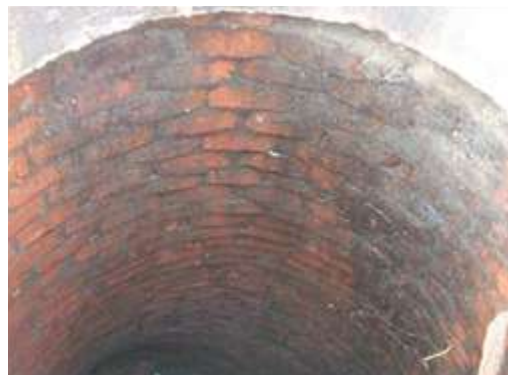
Defect 3

INFILTRATION OF CORBEL

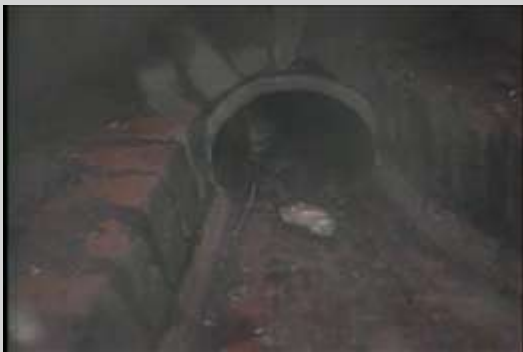
12 O'Clock Outflow

Pipe Height: **8.4** (in.) Rod and Bar (Angled)
Pipe Material: **Clay** ☐ Pipe Lined
Invert Depth: **10.11** (ft.) Flow Characteristics: **Slow**
Deposits: ☐ None ☐ Mud ☐ Sludge ☒ **Debris** ☐ Grease
Silt Depth: **2** (in.) Deposits Extent: **Light**
Infiltration: **None** Pipe Seal Cond: **Sound**

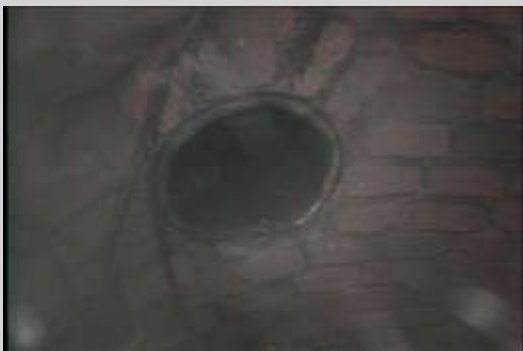
3 O'Clock Inflow

Pipe Height: **8.4** (in.) Rod and Bar (Angled)
Pipe Material: **Clay** ☐ Pipe Lined
Invert Depth: **7.70** (ft.) Flow Characteristics: **Fast**
Deposits: ☒ None ☐ Mud ☐ Sludge ☐ **Debris** ☐ Grease
Silt Depth: (in.) Deposits Extent:
Infiltration: **None** Pipe Seal Cond: **Sound**

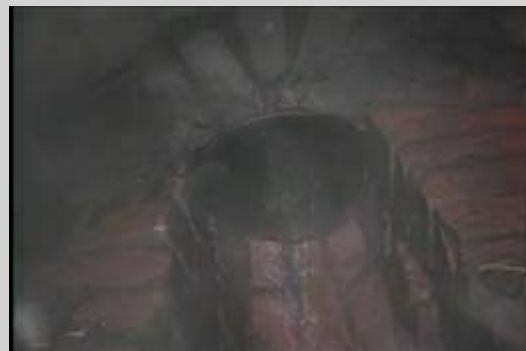
Drop In @ 3 O'Clock

CORRODED STEPS AND ROOT
INTRUSION

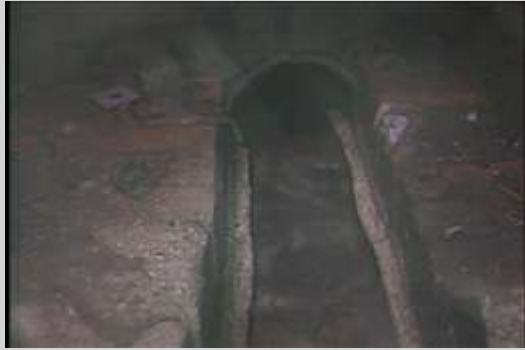
7 O'Clock Inflow

Deposits: ☐ None ☐ Mud ☐ Sludge ☒ **Debris** ☒ **Grease**

Silt Depth: **1** (in.) Deposits Extent: **Light**
